MCPHEETERS LAKE DAM
BUCHANAN COUNTY, MISSOURI
MISSOURI IDENTIFICATION NO. MO 10525

PHASE I INSPECTION REPORT
NATIONAL DAM SAFETY PROGRAM

PREPARED BY
HOSKINS-WESTERN-SONDEREGGER, INC.
CONSULTING ENGINEERS
LINCOLN, NEBRASKA

JUNE, 1980

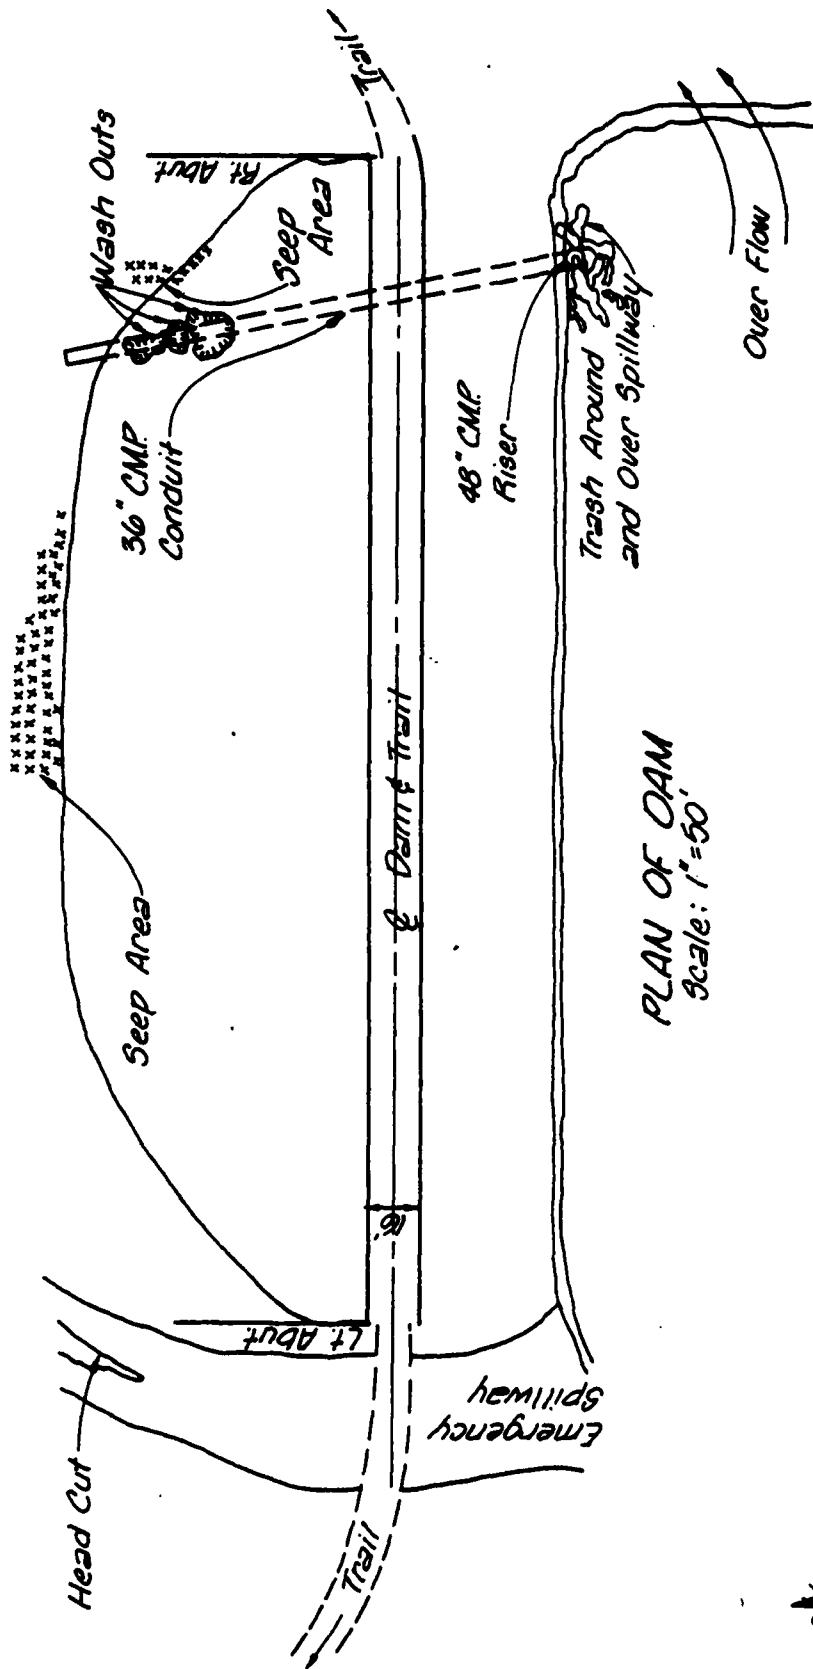
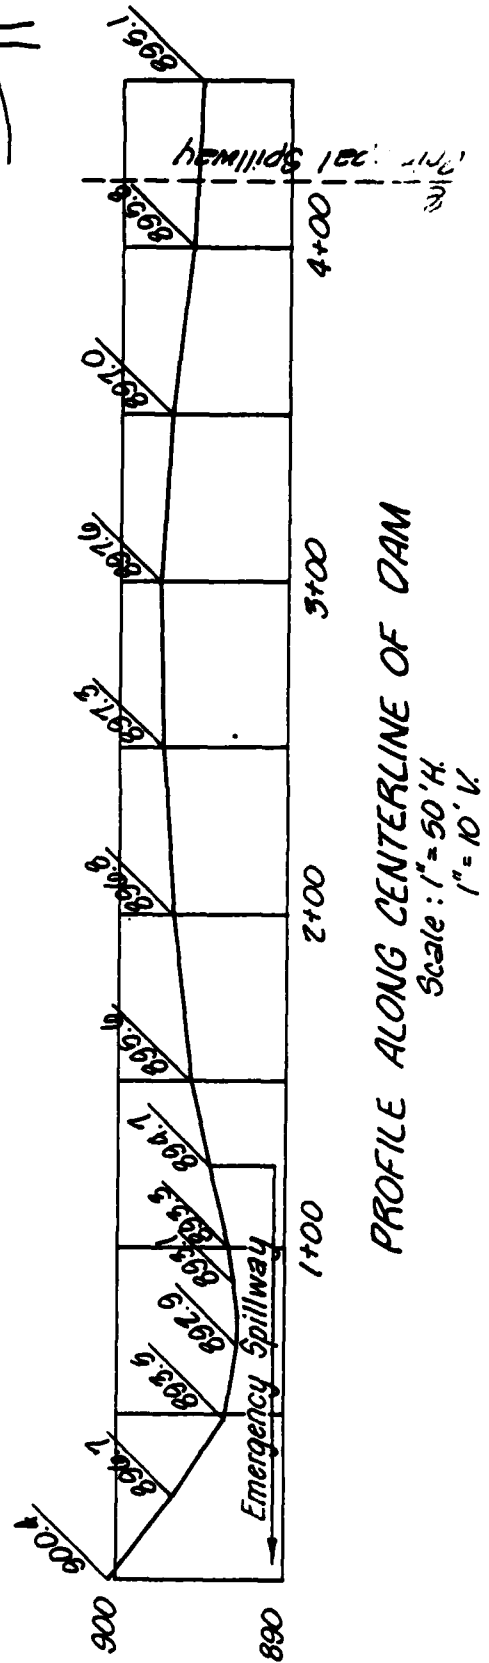
From Plate No. C-1 it can be seen that this dam was constructed with a very high crown (approximately 2.5 feet difference between minimum-top-of-dam and crown). The figures given in the table below appear deceiving because of this. It should also be noted that water begins to flow out of the reservoir over the right (south) bank at the approximate same elevation as minimum-top-of-dam.
